UNITED STATES ENVIRONMENTAL PROTECTION AGENCY
REGION 2
290 BROADWAY
NEW YORK, NY 10007-1866

Re: Phillips 66 Co., Bayway Refinery, Linden NJ
EPA/NJDEP NJPDES Permit Compliance Evaluation Inspection June 12, 13, and 20, 2019
NJPDES Permit No. NJ0001511 (NJPID No. 46318), NJ0026671 (NJPID No. 46322)

Enclosure – Inspection Report from June 2019 CEI

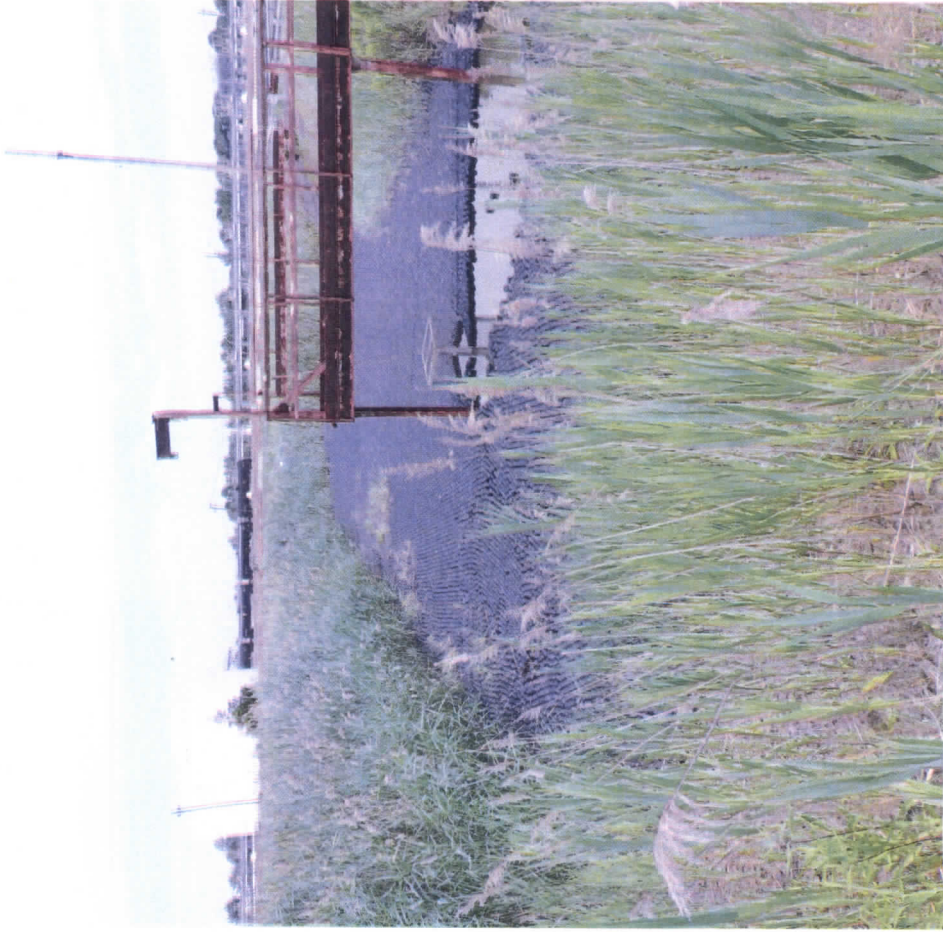
8. For Outfalls 017 and 009 the EPA and NJDEP representatives inquired about whether there the refinery had a program of valve maintenance (017 had a broken valve head).

DSCN6715 – Outfall 017 outlet valves –valves shut – one valve head broken. Discharge occurring over high level weir

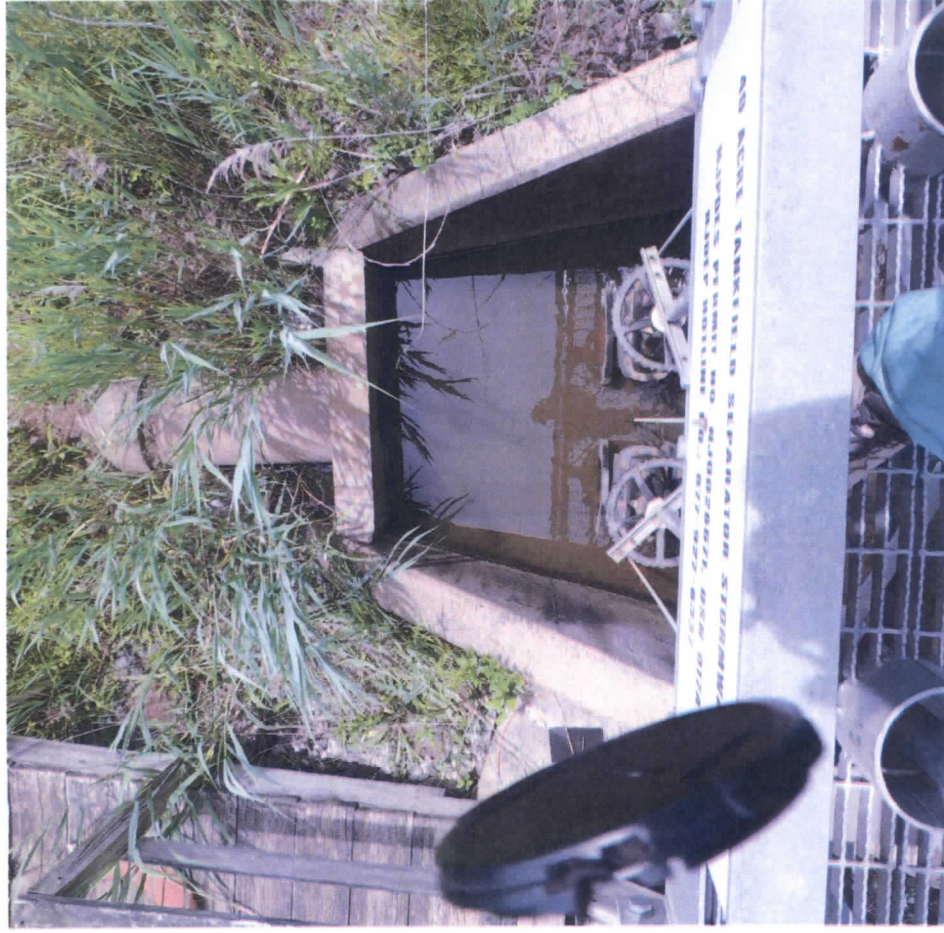
DSCN6717 - One of the 2 Valve Heads at Outfall 017 was broken

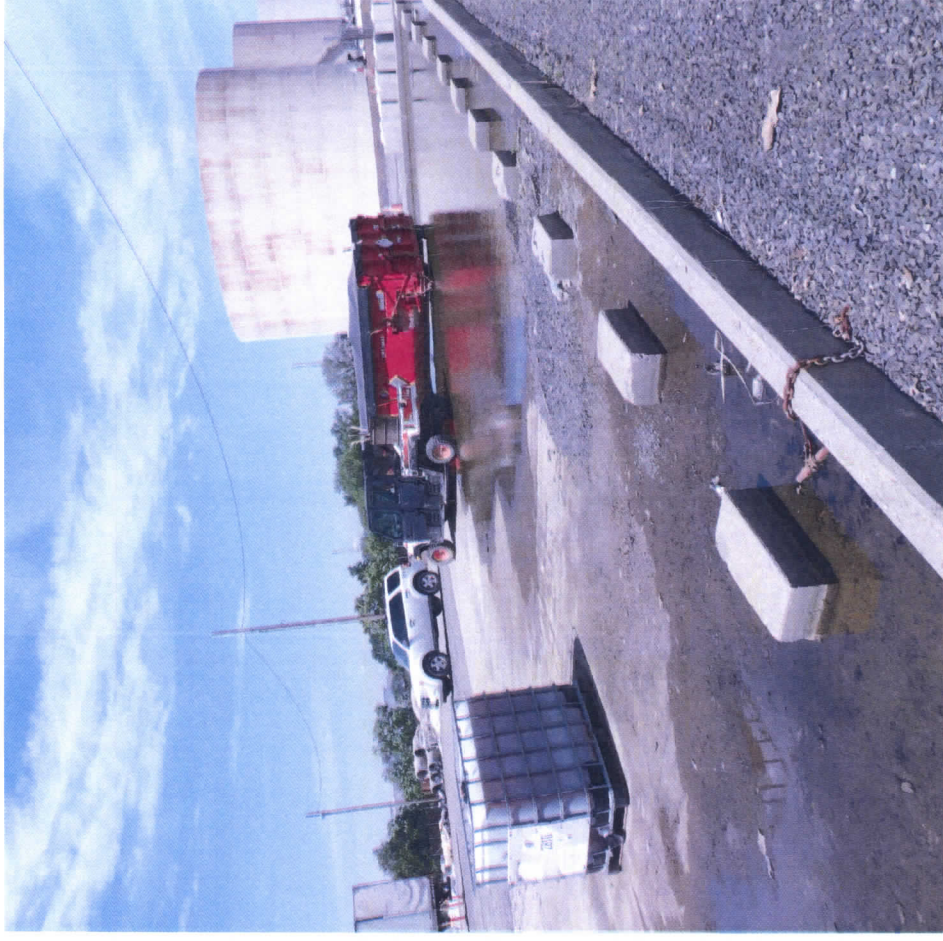
5. As shown in photos 732 to 734 in Att. 1.a there was puddling of water near the hazardous waste staging area drain valves. There was also spalling of the concrete near the drain valves. Please evaluate the source of this water, and eliminate if necessary, any leakage thru the dike.

DSCN6732 – Hazardous waste staging area dike. Puddling near dike valve.

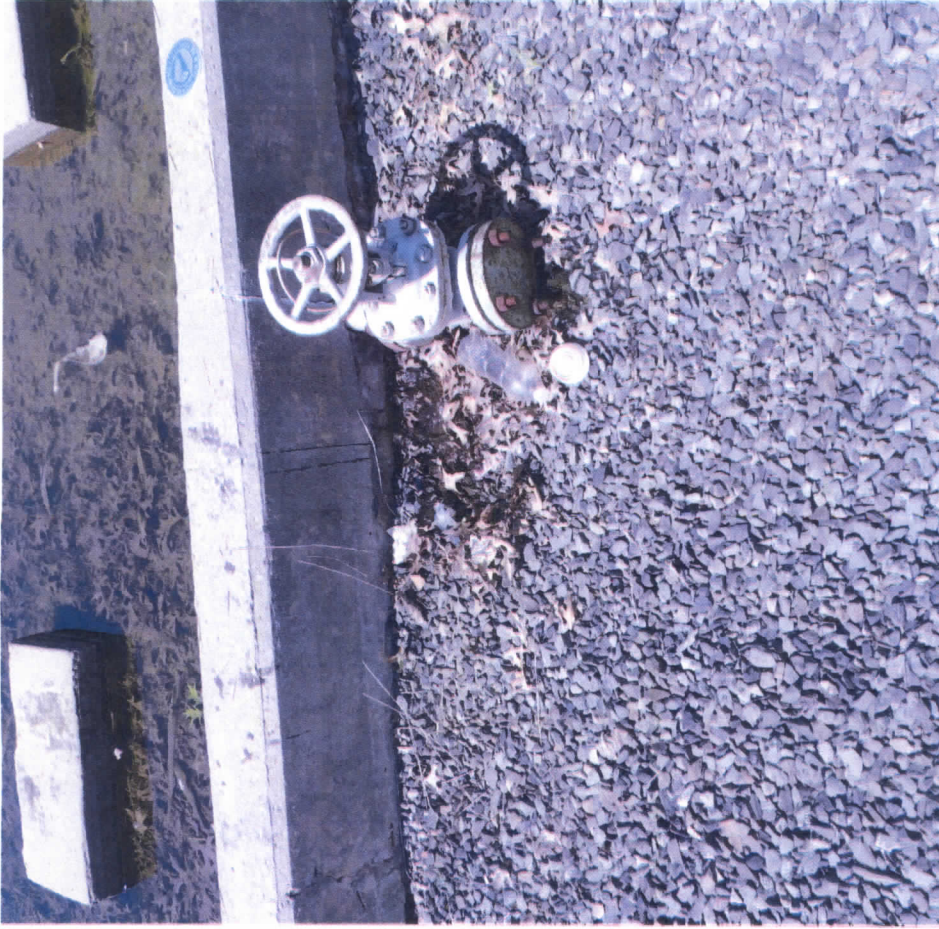
DSCN6733 – hazardous waste staging area and dike

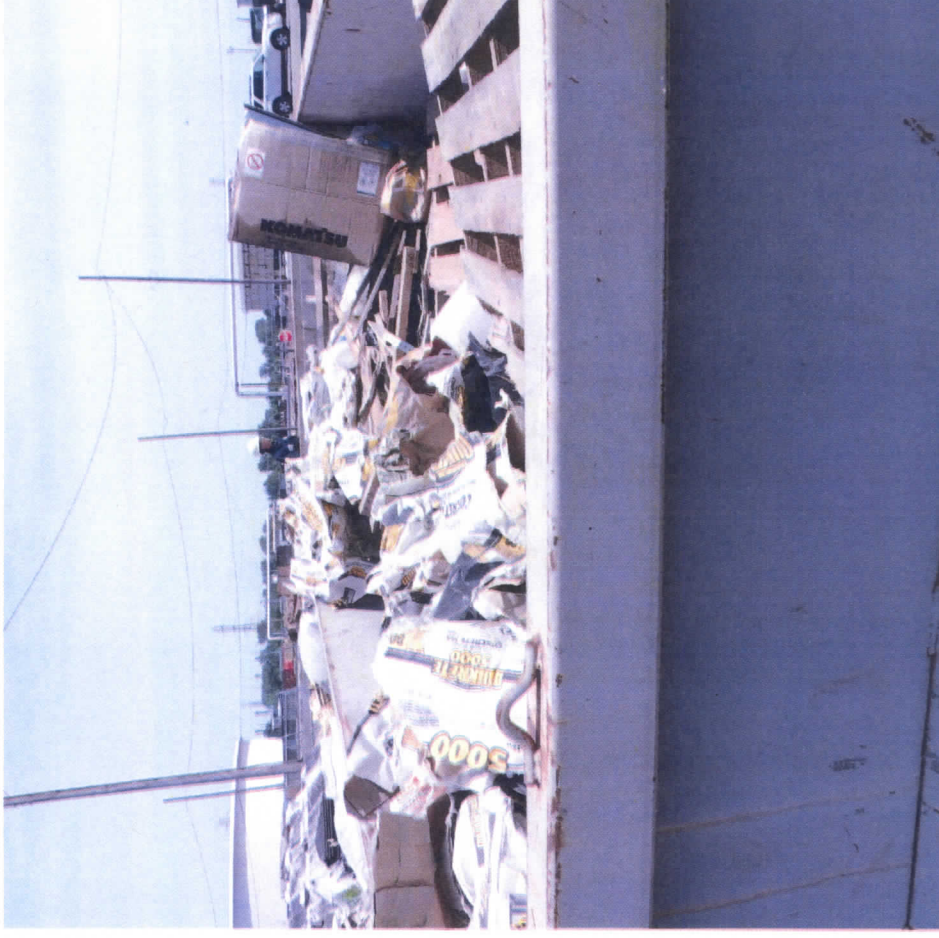
DSCN6734 – hazardous waste storage area dike

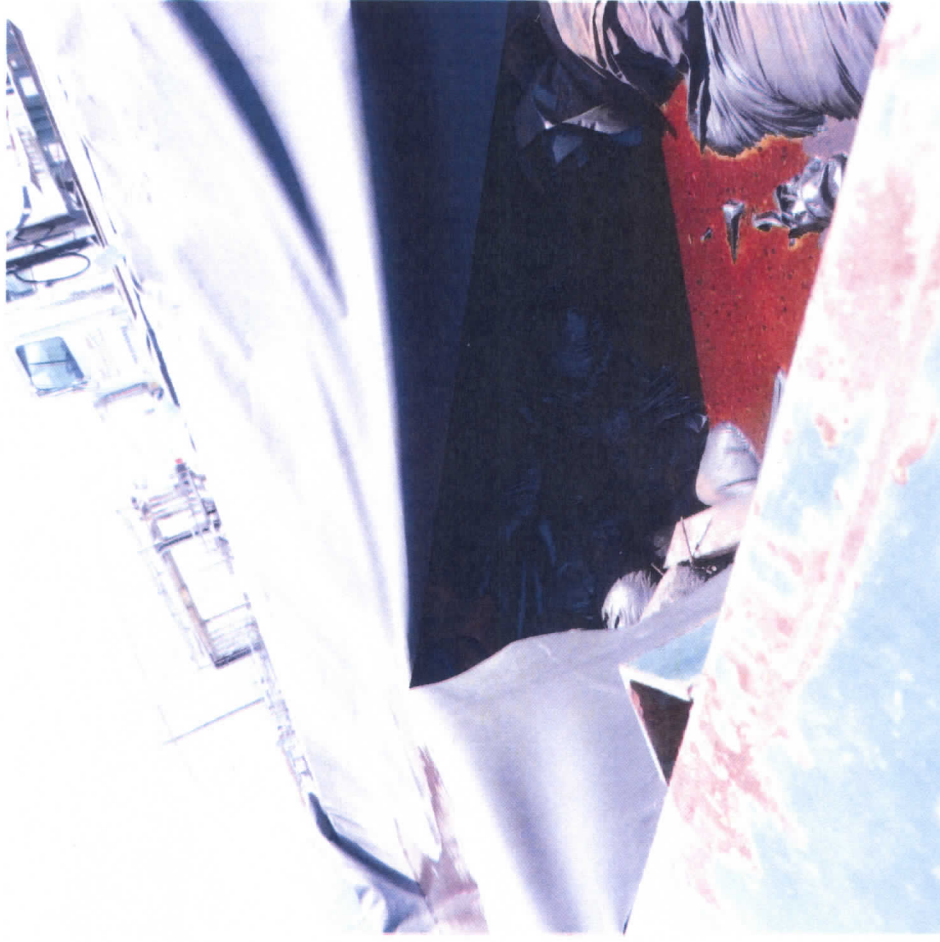
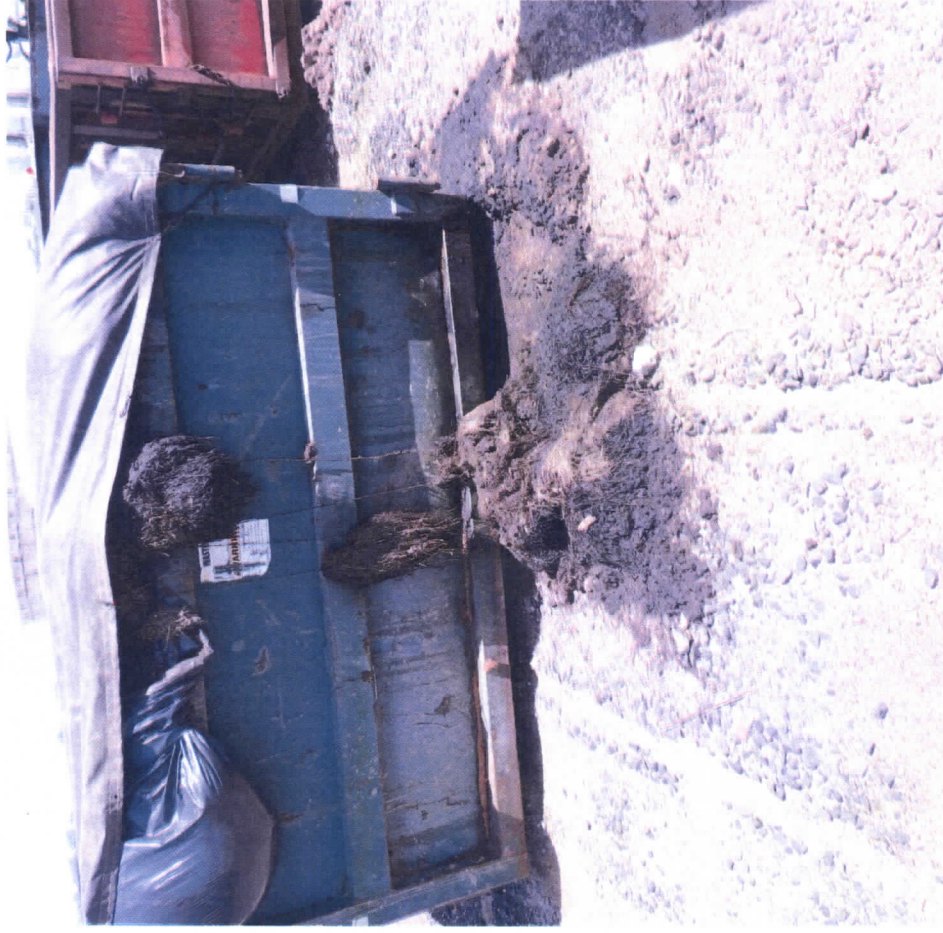
1. As shown in Att. 1.a photos 738 to 744 (June 12, 2019) taken in the Tank 519 Waste Management Area, the Facility failed to properly manage and control waste materials in and around dumpsters as required by Stormwater Part F.1.f.ii of the SW Permit. Additionally, Part E.1 requires proper operation and maintenance of the facility. Part VI of the Facility's Stormwater Pollution Prevention Plan ("SPPP") requires roll-offs to be covered except when being loaded or unloaded and requires weekly inspections. The inspection identified that:

- a. Dumpster covers were torn and not being maintained.
 - b. Dumpsters contained oil wastewater/stormwater and were leaking on the ground.
 - c. Oily material/hay was seen outside of the dumpsters.

The Facility representative indicated that this area was to be inspected once per week, however judging by the condition of the covers and accumulation of oil water inside and around the dumpsters it does not appear that weekly inspections were taking place. The Facility representative said that they would report this to NJDEP by filing an incident report of discharge to ground. This portion of the Facility was not being operated and maintained in accordance with Part E and F of the SW Permit.

DSCN6738 – oily wastewater/stormwater in dumpster with cover partially off, dumpsters were leaking – Tank 519 Waste Mgmt. Area

DSCN6739 - oily wastewater/stormwater in dumpster with cover partially off, dumpsters were leaking - - Tank 519 Waste Mgmt. Area

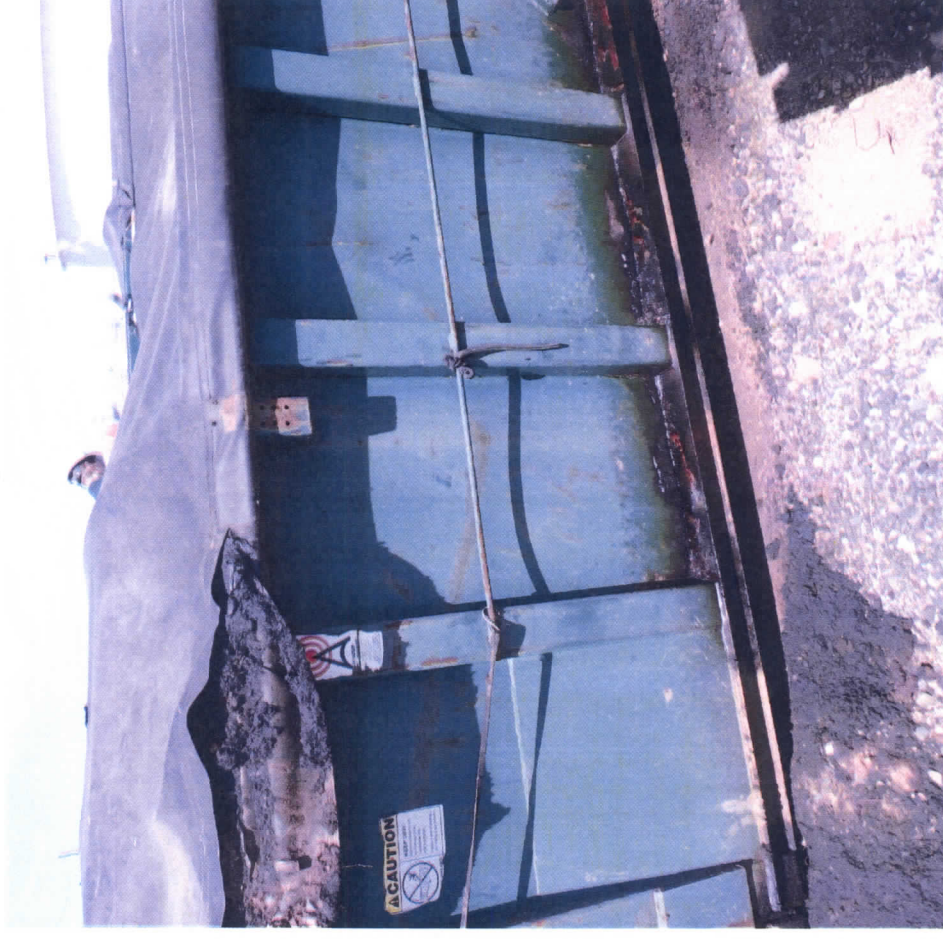
DSCN6740 – hay and oily material outside of partially covered dumpster

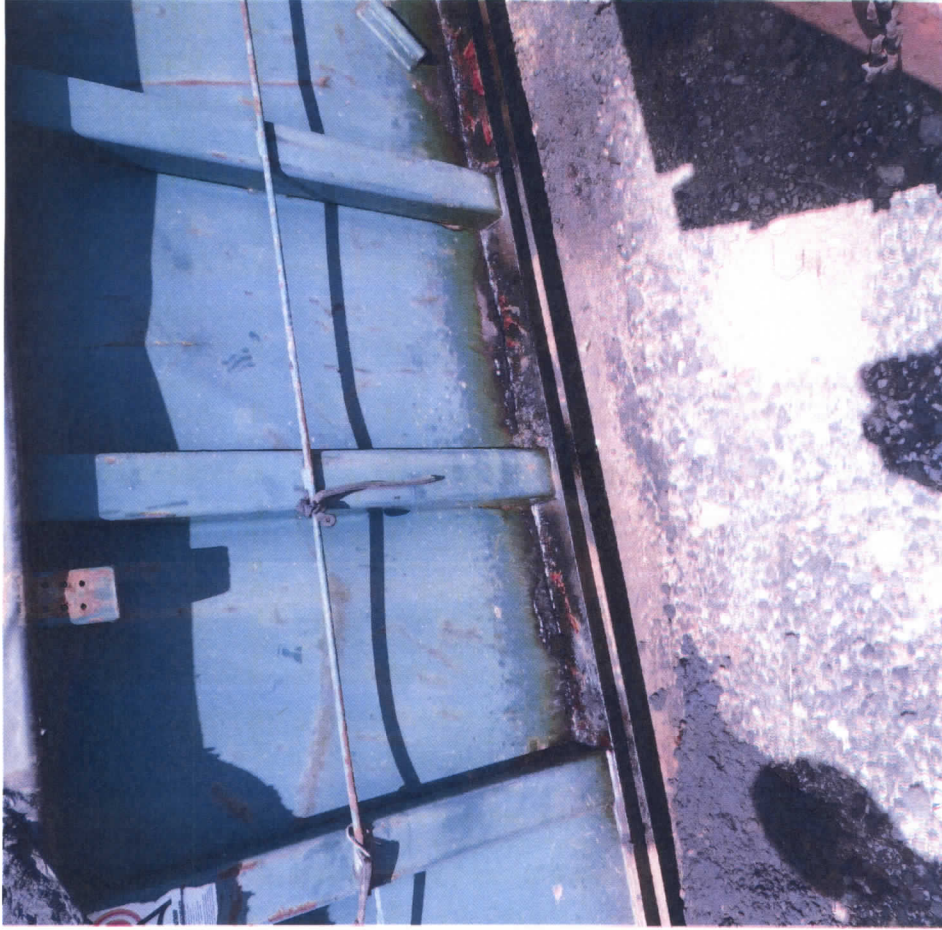
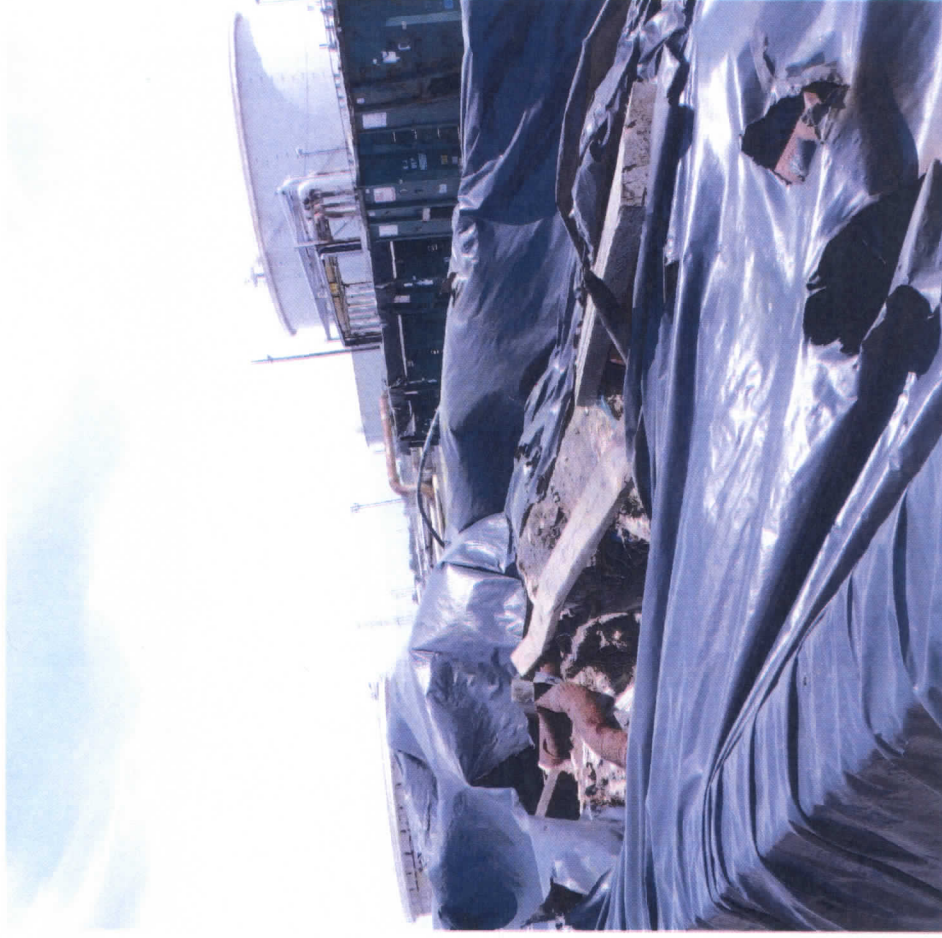
DSCN6741 – leakage of oily material outside of dumpster
with oily wastewater/stormwater outside of dumpster

DSCN6742 - leakage of oily material outside of dumpster
with oily wastewater/stormwater outside of dumpster

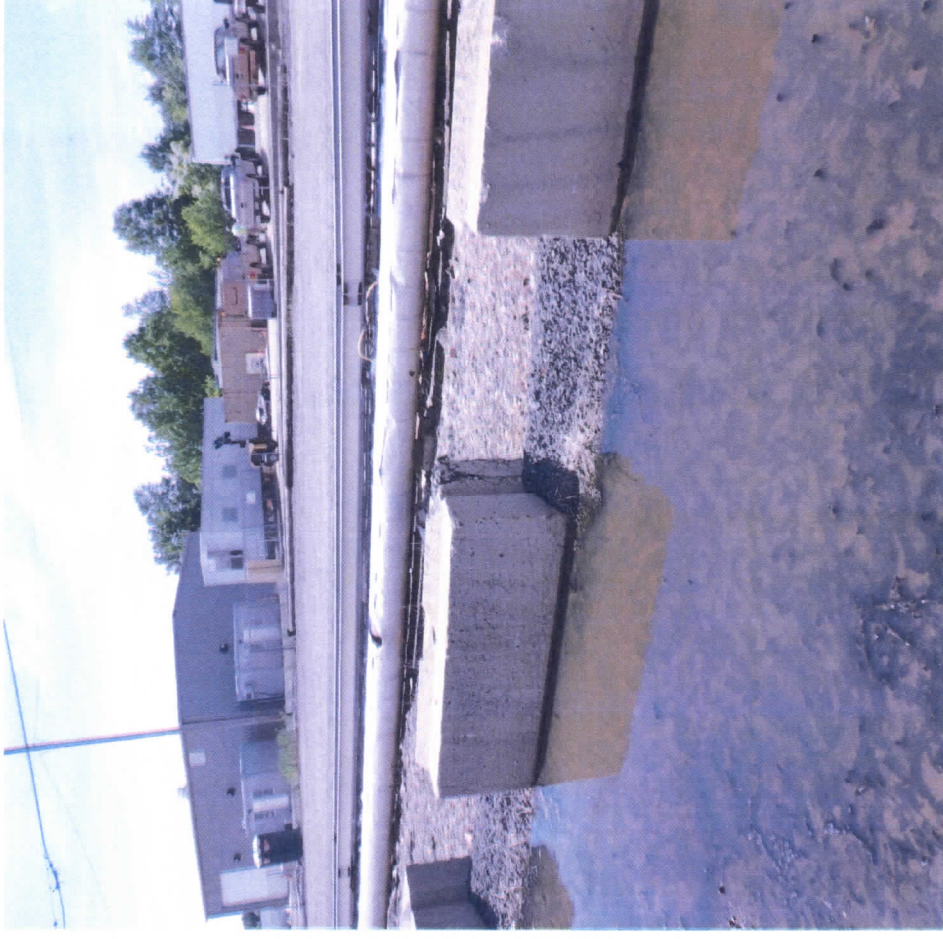
DSCN6744 – pellets outside of dumpster on ground in tank 519 waste area

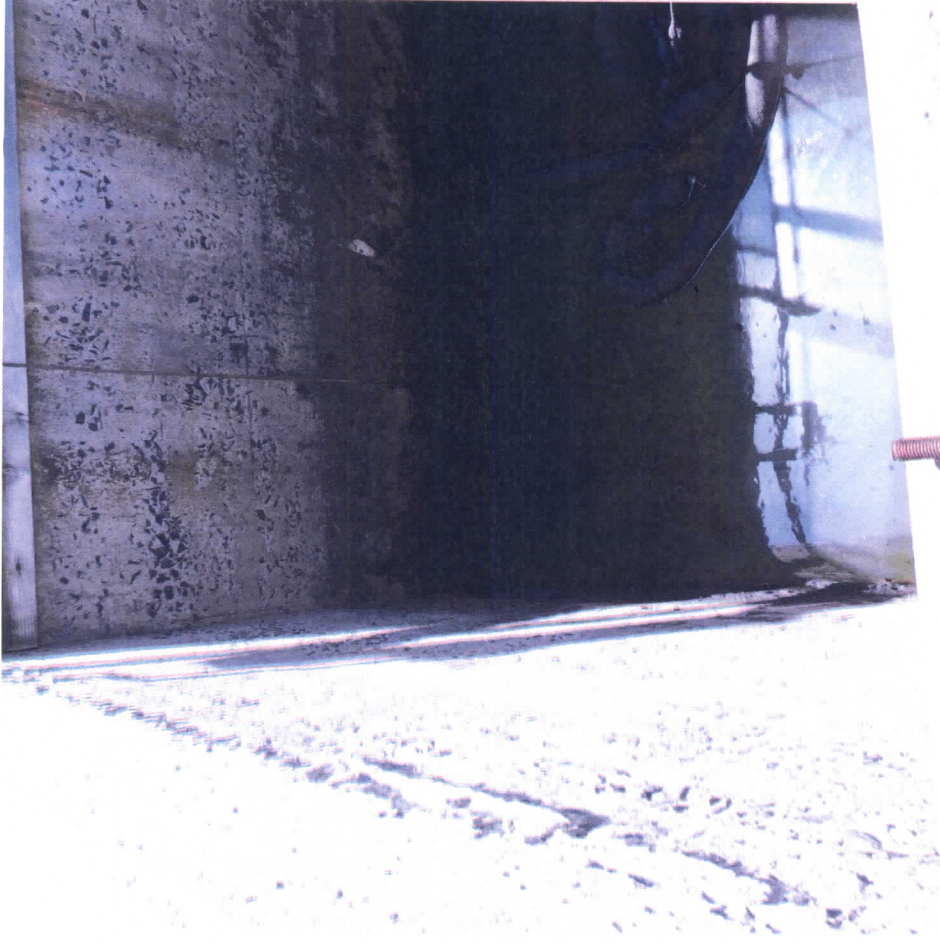
5	010	748-753	<p>As shown in photos 748 to 752 (taken on June 12, 2019) (Att. 1a), the Tremley Tank Field separator had a layer floating oil in the separator, the banks were oil stained, and there was a sheen and an oily sorbent pig in the outlet chamber prior to the outlet valve. Outfall 010 discharges to Moses Creek, but has no monitoring requirements in the SW Permit. The Facility representative said that this separator drains a large tank field, but there is no process sewer in the vicinity to route flows to the WWTP. During the June 12, 2019 inspection, as shown in photo 753 the outlet of the 010 channel prior to entering Moses Creek did not have a sheen.</p> <p>Daily visual inspections of the Tremley separator are conducted and records for January through June 2019 were provided to EPA following the inspection. However, the visual inspections of the separator on June from 11, 12, and 13 (Att. 5) did not identify any accumulated oil in the outlet box. But EPA and NJDEP did identify a sheen and oily sorbent pig in the outlet box on June 12, 2019.</p> <p>Proper operation and maintenance of the separator (a Best Management Practice) is required under Parts IV.E.F. and G of the SW Permit in accordance with the Permit. And Operators should be trained to identify oil in the outlet box as well as a layer of oil in the separator itself that necessitates cleaning of the Separator.</p> <p>The outfall from this separator does not currently have chemical monitoring requirements in the permit, but NJDEP has requested that monitoring of the discharges from this outfall be conducted for parameters and frequency consistent with other outfalls in the stormwater permit.</p>	PNC

DSCN6748 - Tremley Tank Farm Outfall 010 separator, layer of floating oil seen in the separator and staining the banks

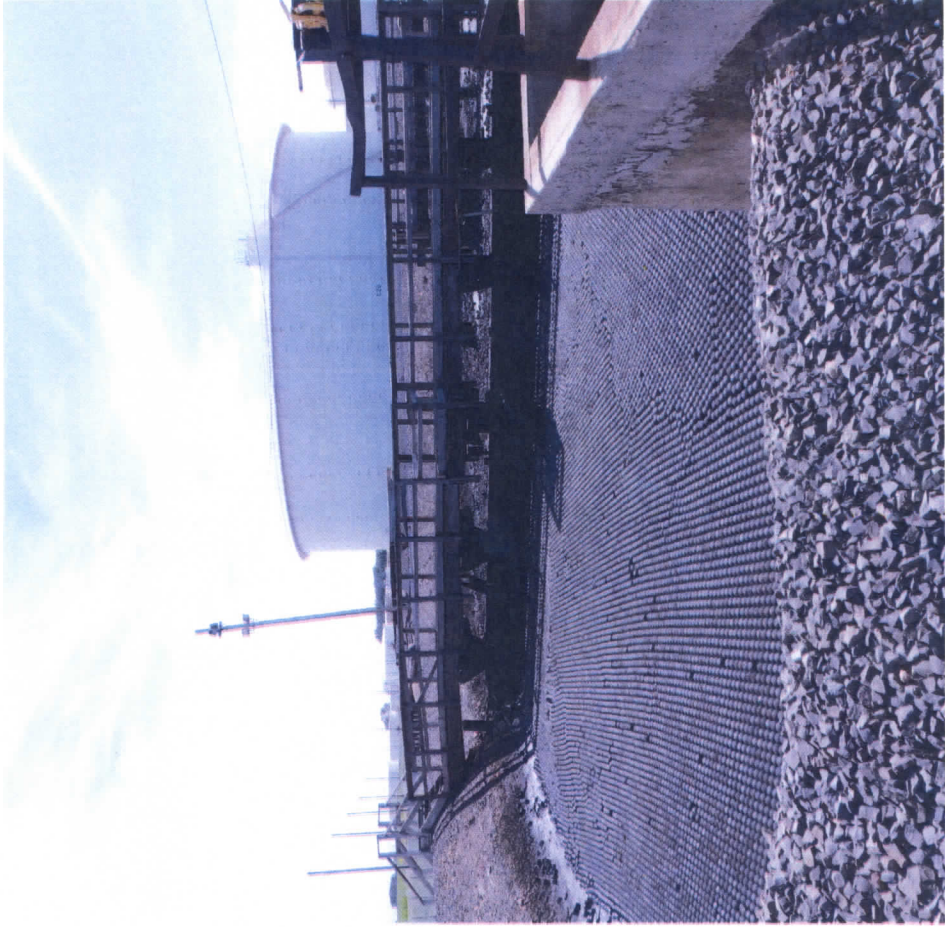
DSCN6749 – Tremley separator, Outfall 010, oily wastewater and oily boom/pig seen in the outlet chamber prior to the outlet valve

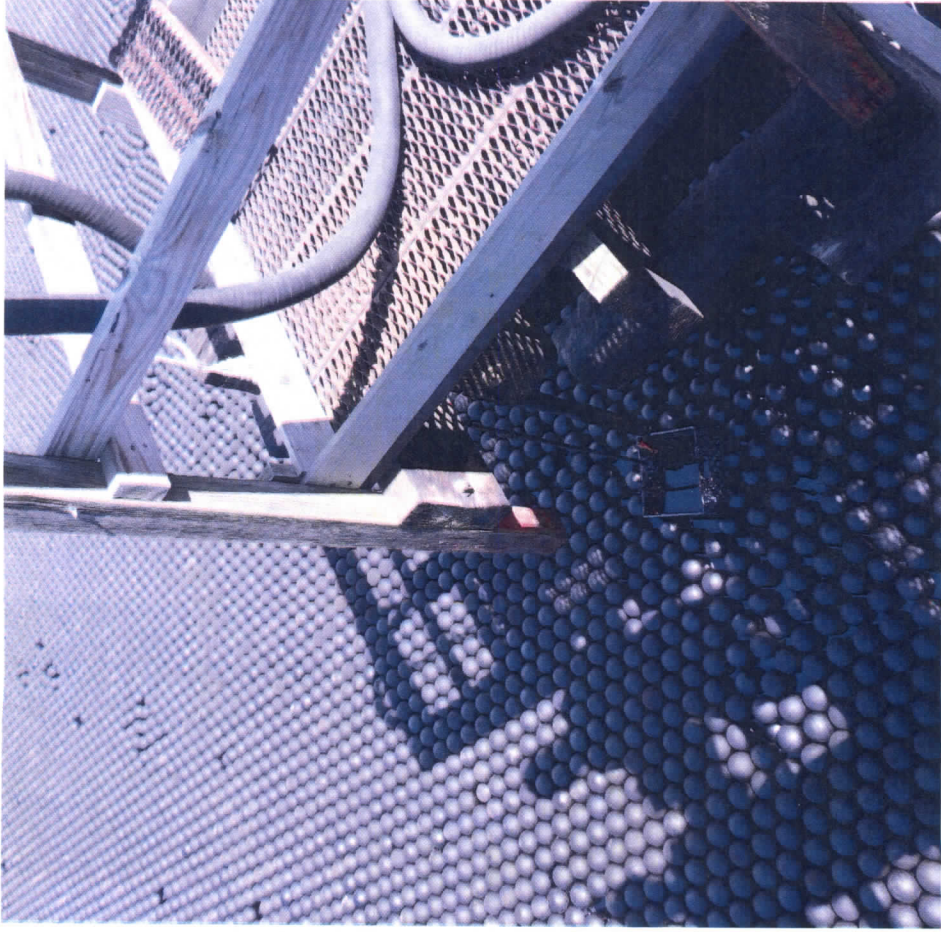
DSCN6750 - Tremley Tank Farm Outfall 010 separator, layer of floating oil seen in the separator and staining the banks

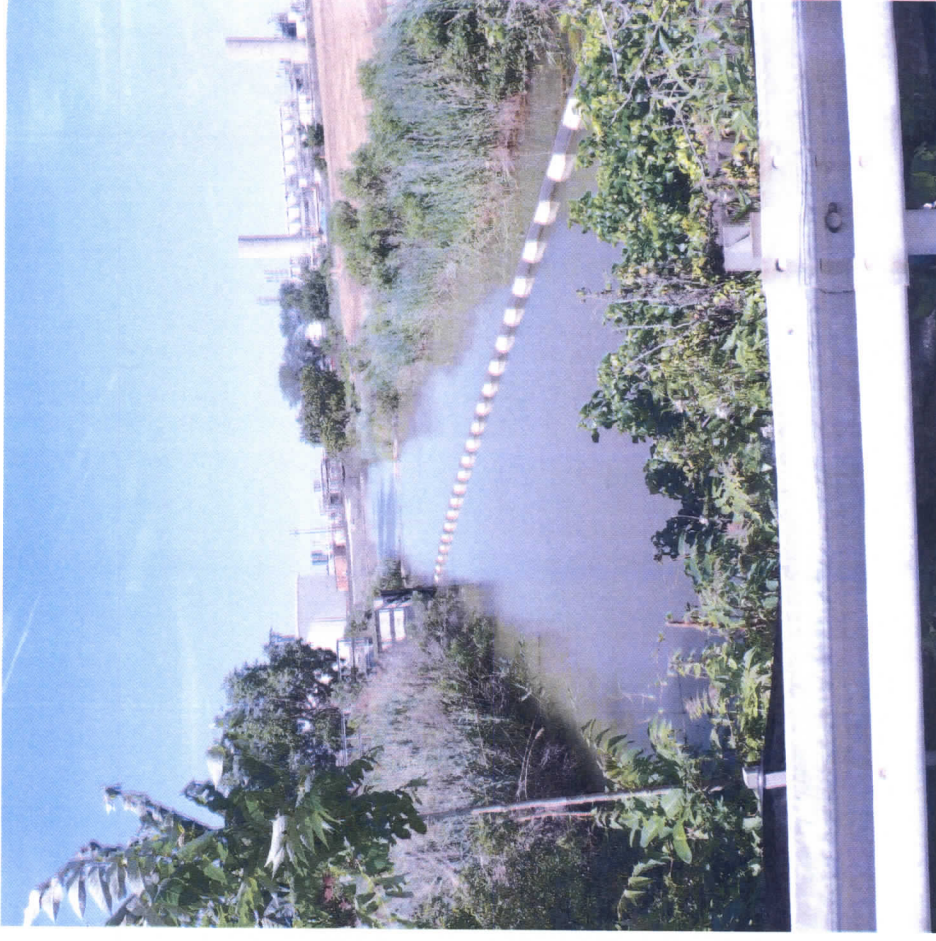
DSCN6752 - Tremley Tank Farm Outfall 010 separator, layer of floating oil seen in the separator and staining the banks

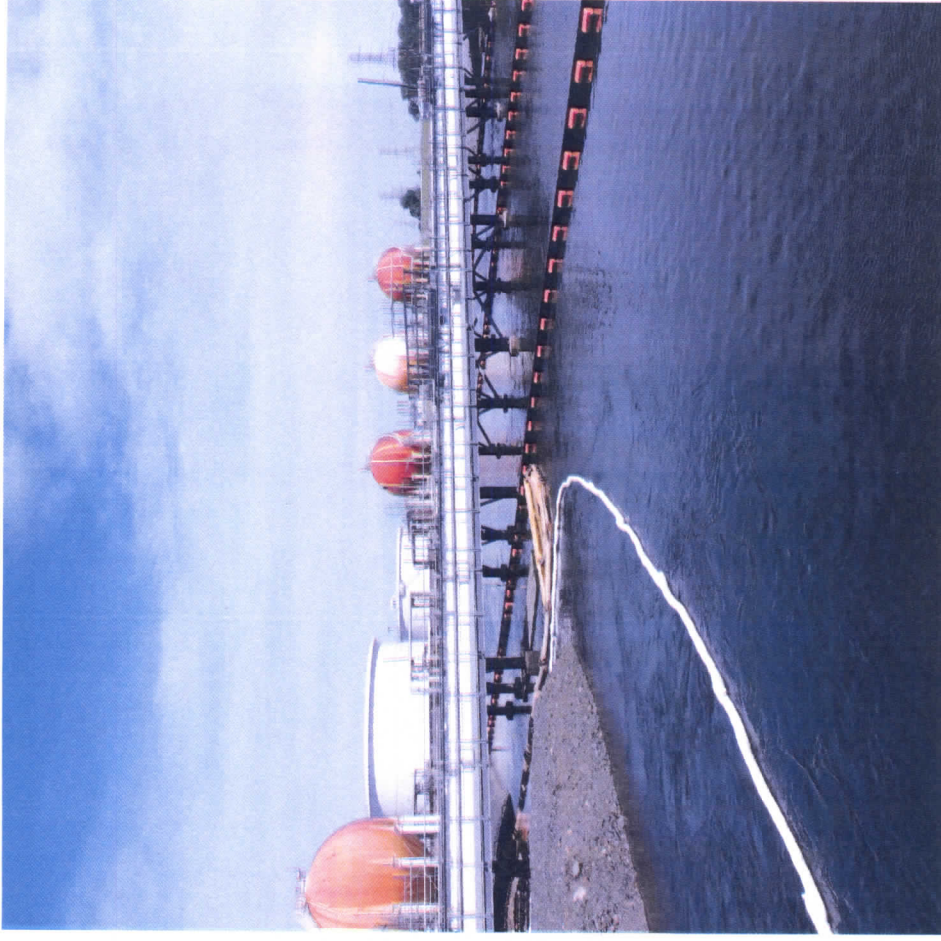
DSCN6760 - oil was seen in the first part of the 003 separator

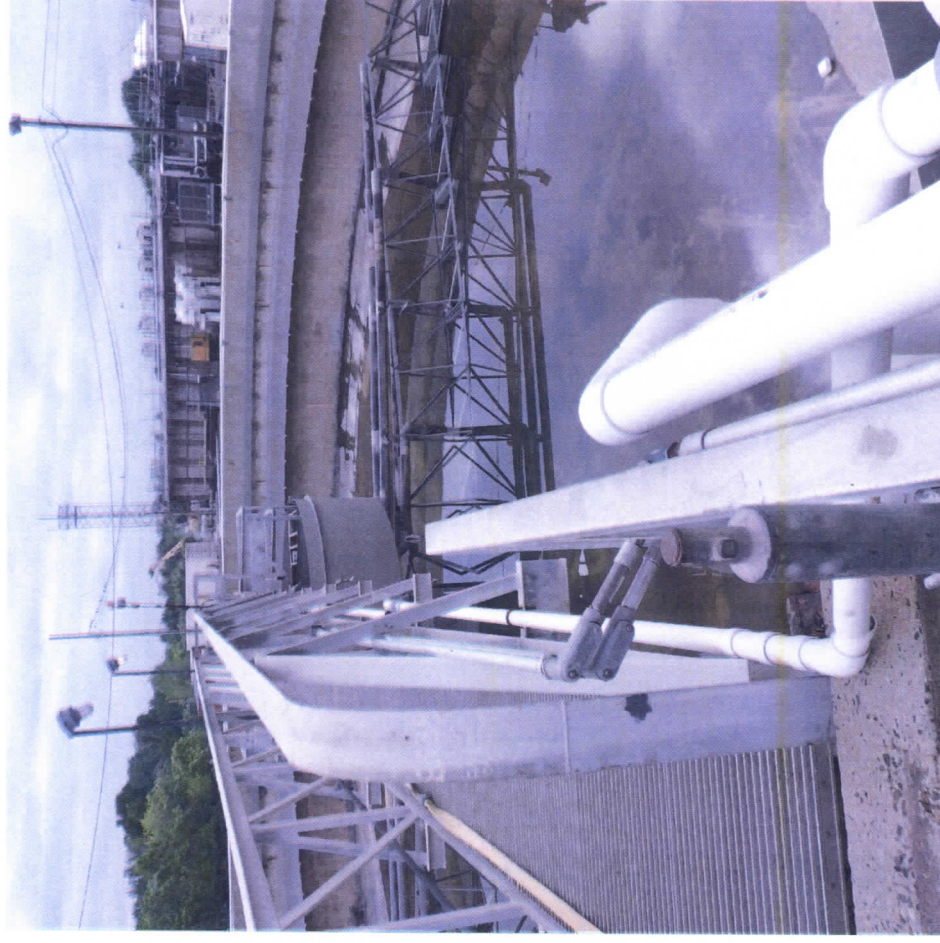
4. There are 3 final clarifiers at the facility:
 - a. As shown in photograph No.797 Att. 1.b. there is a missing weir plate in Clarifier No. 1. Weir plates in the clarifiers must be replaced to avoid short circuiting of the clarifier.

DSCN6797 – missing a weir plate in the final clarifier No. 1

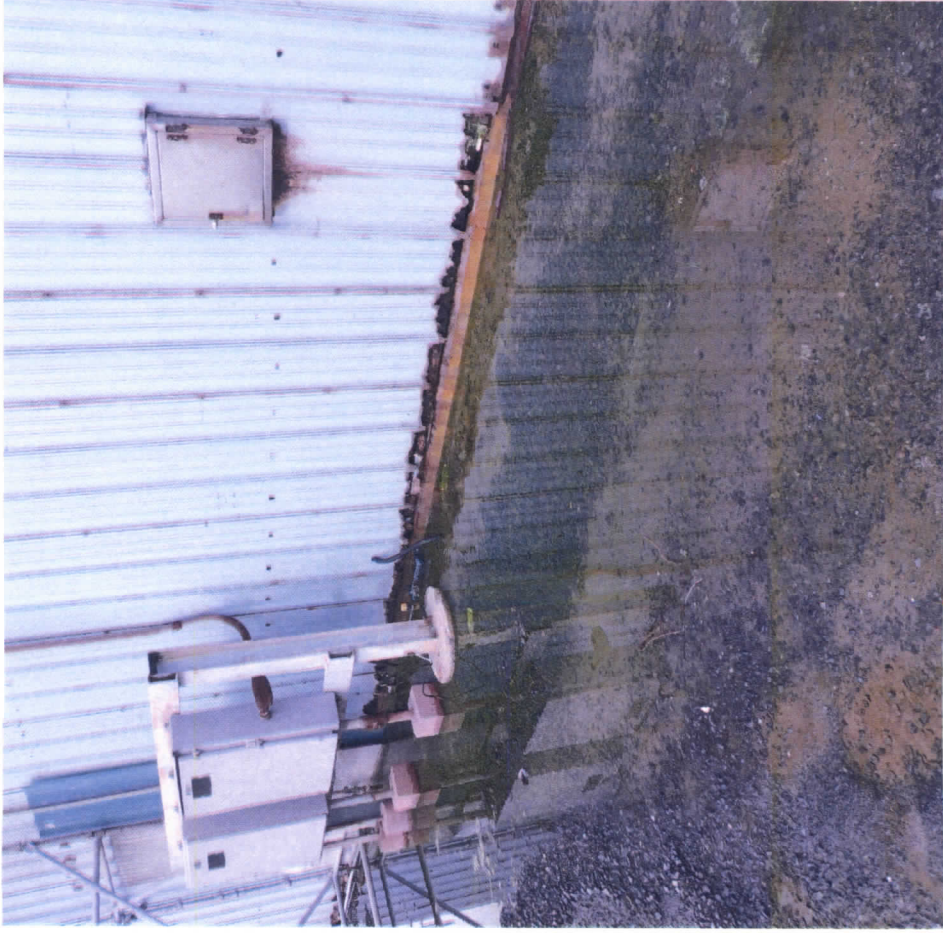
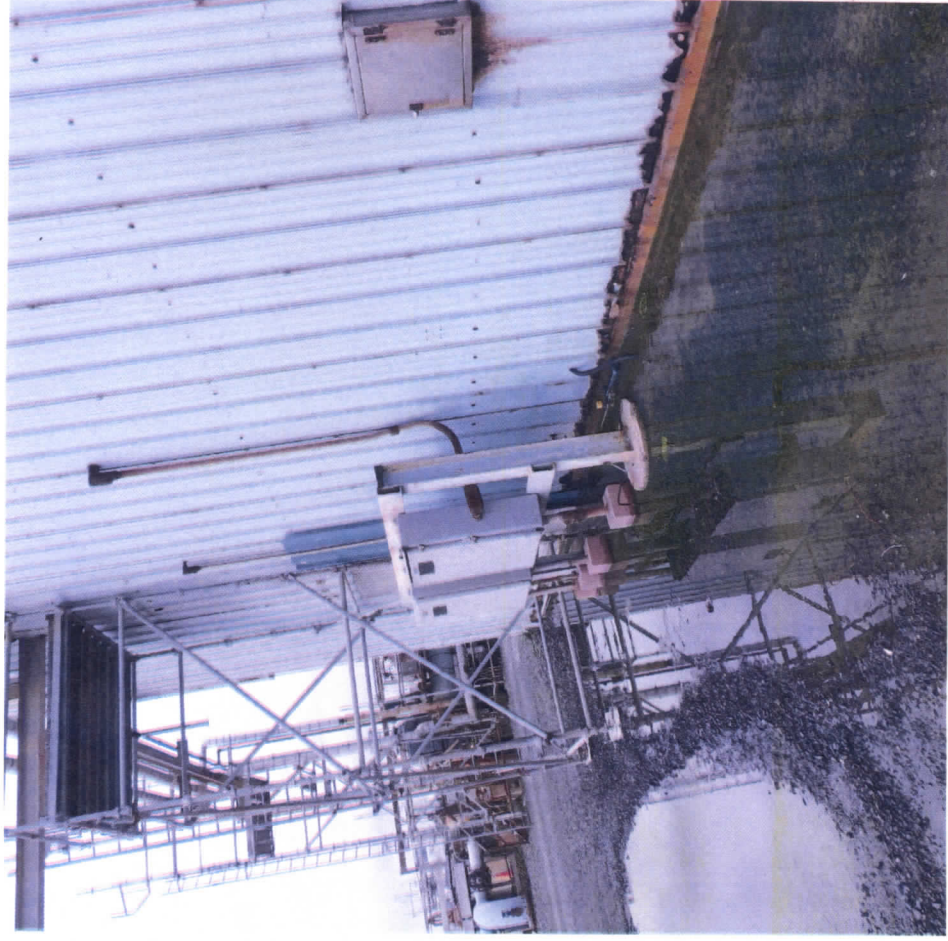
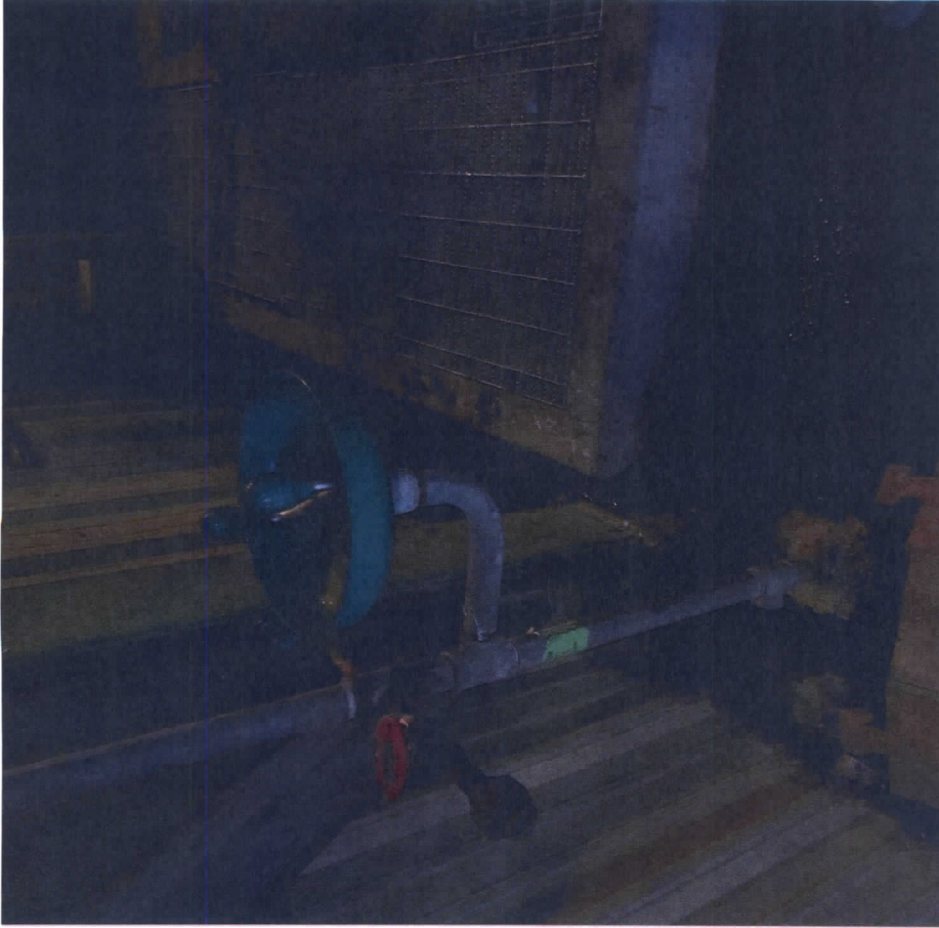
- b. As shown in photos 800 to 804 (Att.1b) there is a broken water line ((said to be operated by American Water) inside the filter building. Water is seen puddling and flowing outside of the filter building.

DSCN6800 – water from a broken potable water line puddling outside of filter building

DSCN6801 - water from a broken potable water line puddling
outside of filter building

DSCN6802 - water from a broken potable water line puddling
outside of filter building

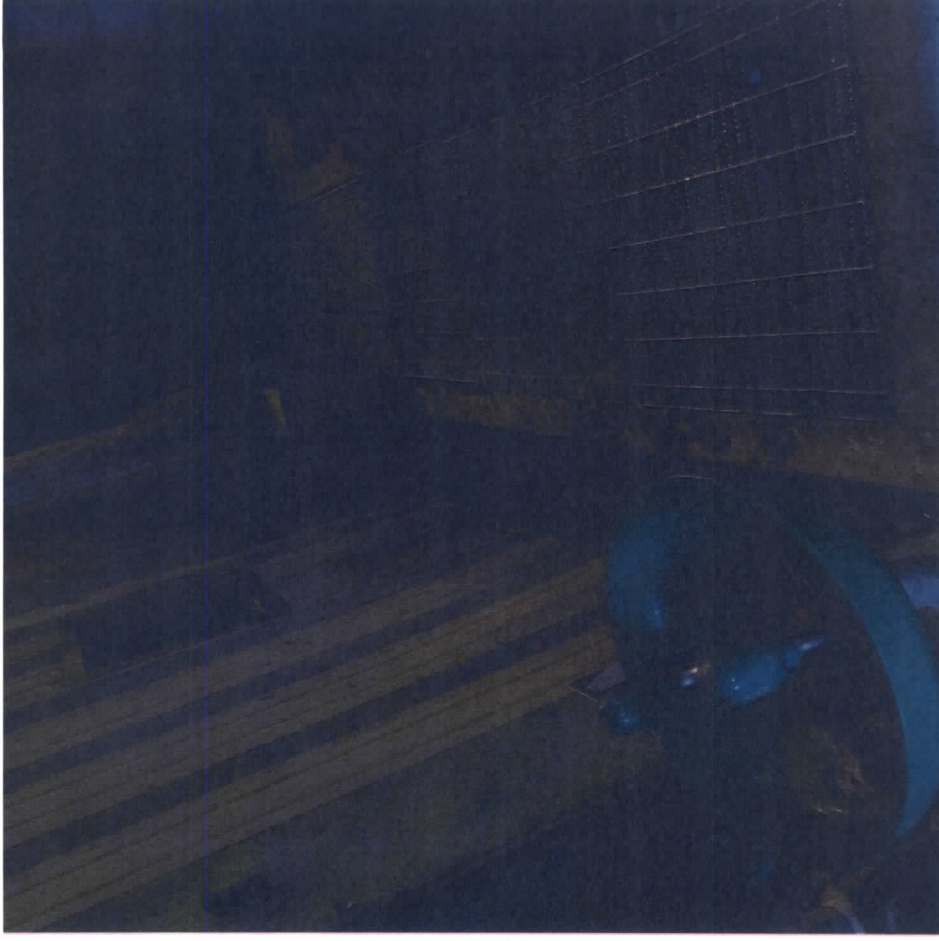
DSCN6803 – potable water line leak inside the filter building

DSCN6804 – potable water line leak inside the filter building

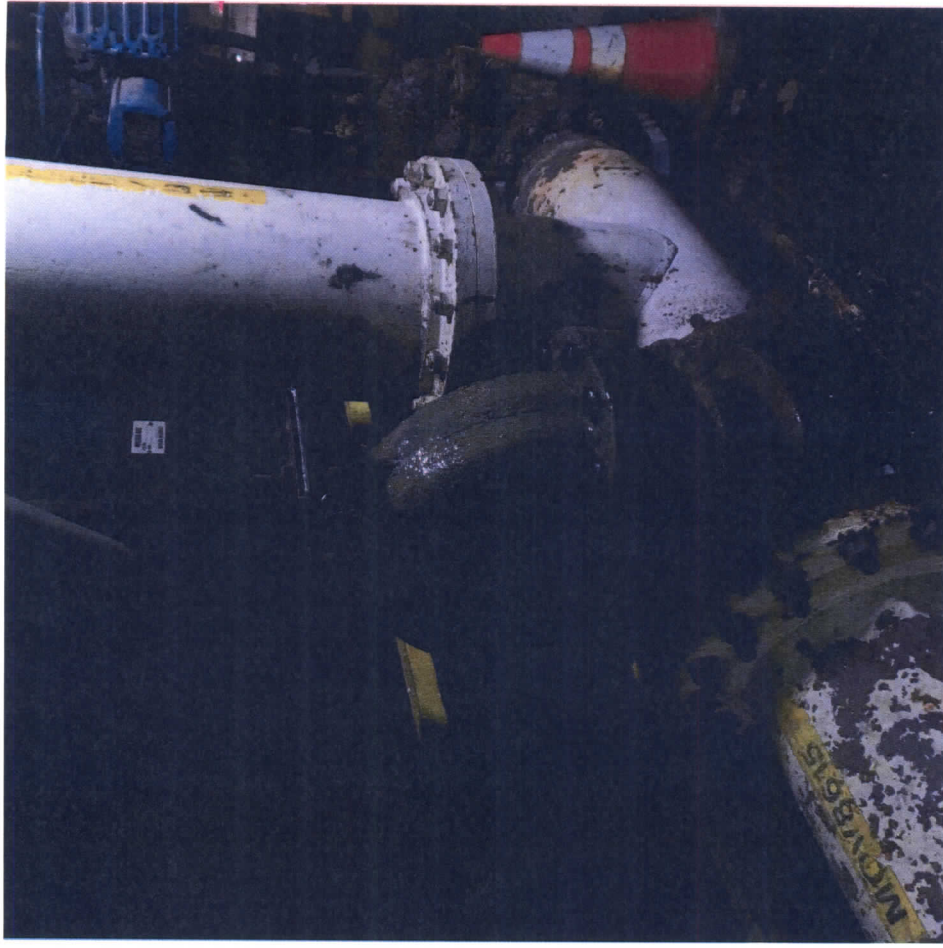
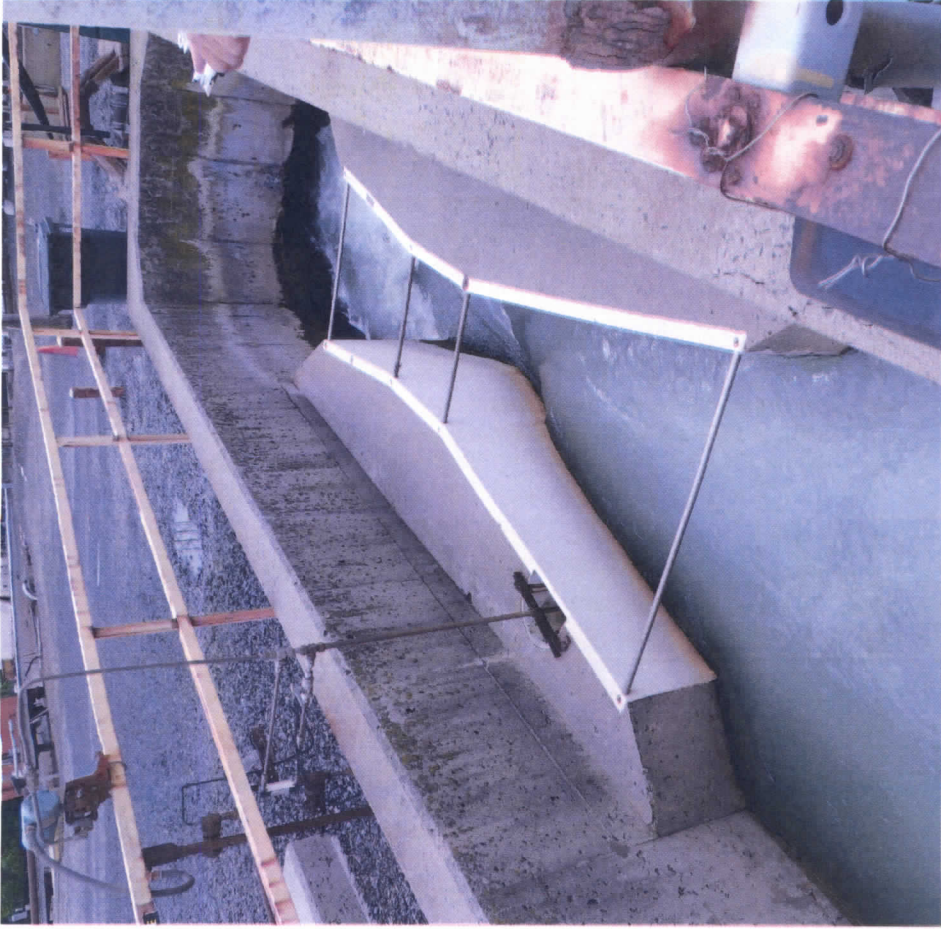
- c. As shown in photos 805 and 806 (Att. 1.b) there are gate valves associated with the filters that are leaking. The facility representative indicated that they were planning on replacing the gate valves with butterfly valves to eliminate leakage. Please provide the status of the gate valve replacement.

DSCN6805 – leaking gate valve associated with filter

DSCN6806 - - leaking gate valve associated with filter

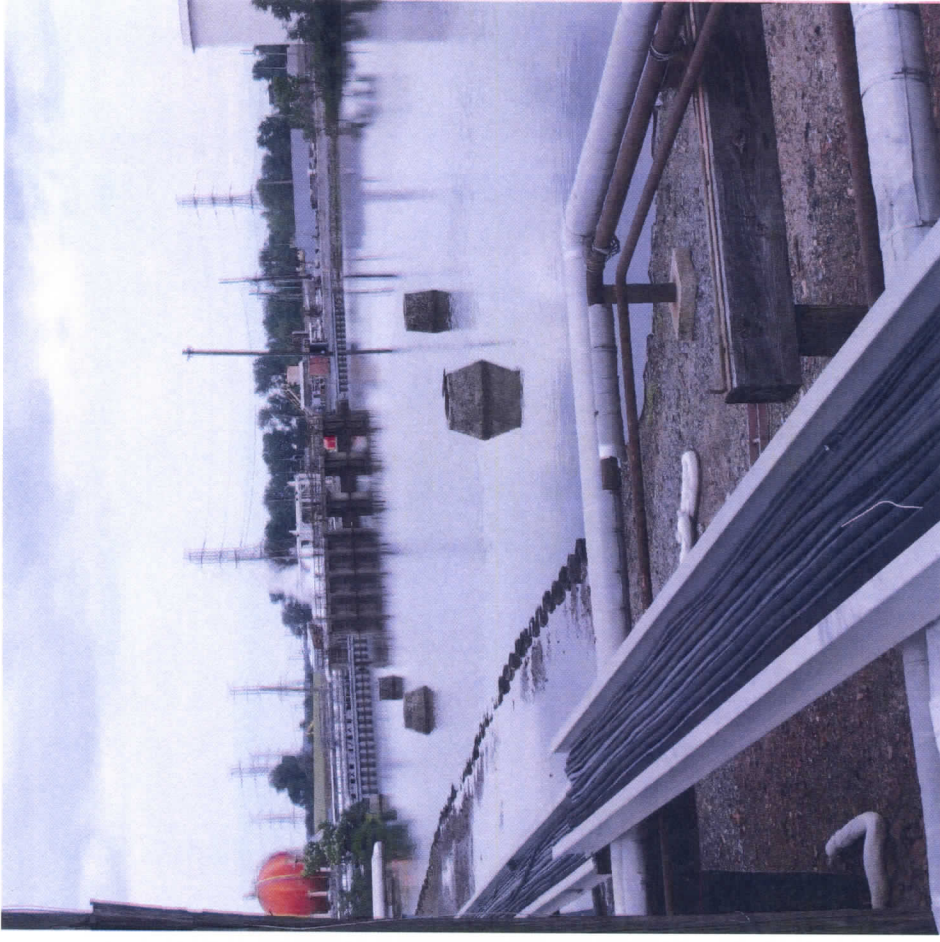
DSCN6809 – Outfall 002 composite sampler, amber glass bottles for organics, had Teflon tubing as well.
